**Active wear and failure mechanisms
of TiN-coated high speed steel and
TiN-coated cemented carbide
tools when machining powder
metallurgically made stainless steels**

Active Wear and Failure Mechanisms of TiN-Coated High Speed Steel and TiN-Coated Cemented Carbide Tools When Machining Powder Metallurgically Made Stainless Steels

LAIZHU JIANG, HANNU HÄNNINEN, JUKKA PARO, and VEIJO KAUPPINEN

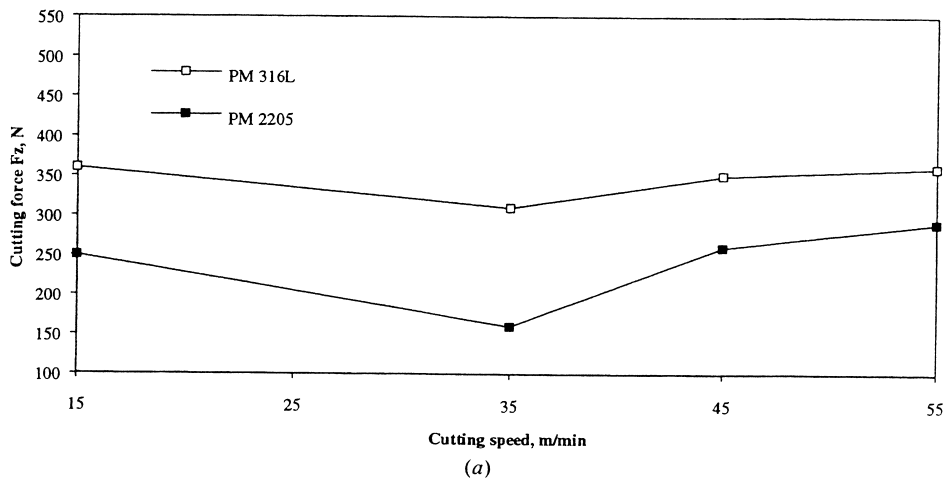
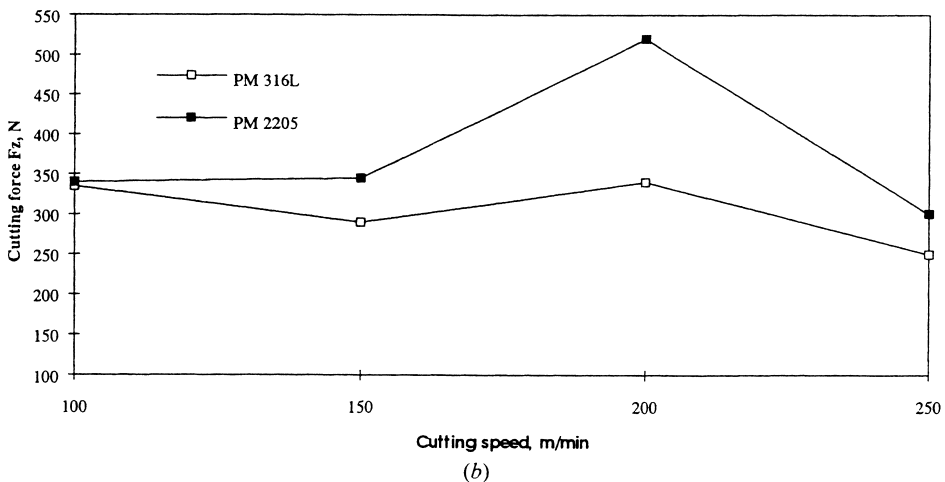
Fig. 2—Cutting forces when machining PM 316L and PM 2205 steels in low and high cutting speed ranges: (a) in the low cutting speed range using TiN-coated HSS tool; and (b) in the high cutting speed range using TiN-coated cemented carbide tool.

The principal cutting forces when machining PM 316L and PM 2205 steels in low and high cutting speed ranges are shown in Figures 2(a) and (b), respectively. It can be seen that the principal cutting forces when machining PM 2205 steel are lower than those when machining PM 316L steel in the low cutting speed range, whereas the opposite is true in the high cutting speed range.

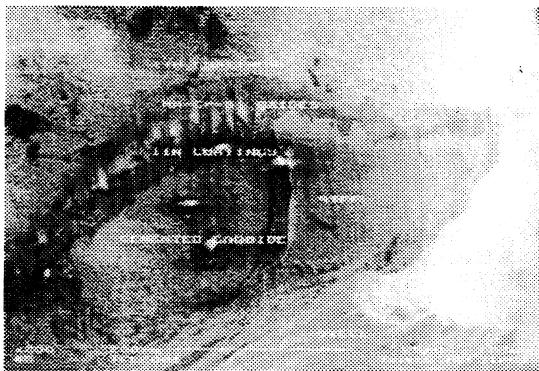
Fig. 8—Wear morphology and related EDS analyses of TiN-coated cemented carbide tool when machining PM 316L steel at a cutting speed of 45 m/min.

phology of the flank surface of TiN-coated cemented carbide tool when machining PM 316L steel at a cutting speed of 200 m/min, together with EDS analyses, is shown in Figure 8.

served bonding to TiN coating, while the workpiece layers are seen to bond to cemented carbide substrate on the flank surface. It can also be noticed that, of all the elements of the workpiece, only Ni and Mo diffused into the tool substrate, while only Co of the tool elements diffused into the workpiece. It is well known that both Ni and Co have similar crystal structure and close lattice constants at high-temperature leading to the substitutional diffusion: Ni diffuses from the workpiece into the tool substrate, while Co diffuses from the tool substrate into the workpiece. Molybdenum has the similar ability to form carbide as W, and accordingly, it is able to diffuse from the workpiece into the tool substrate, partially replacing W in the carbides.

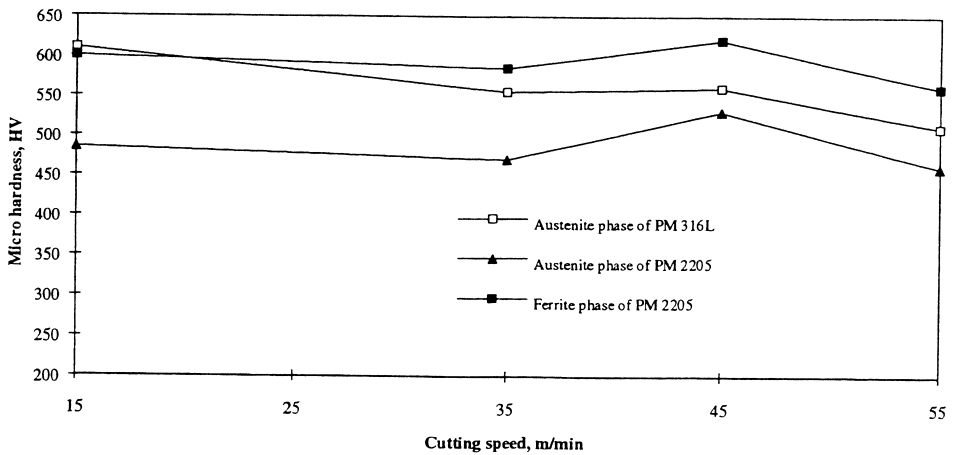
Fig. 13—Microhardness of austenite phase of PM 316L and both austenite and ferrite phases of PM 2205 steel at chip bottom in the low cutting speed range.

in the low cutting speed range, as an example, are shown in Figure 13. As compared with the original microhardness, it can be seen that the austenite phase of PM 316L steel and both the austenite and ferrite phases of PM 2205 steel undergo marked work hardening during machining. Further, it can be seen that the degree of work hardening (the change of microhardness value after turning) of PM 316L steel is much higher as compared with that of PM 2205 steel.

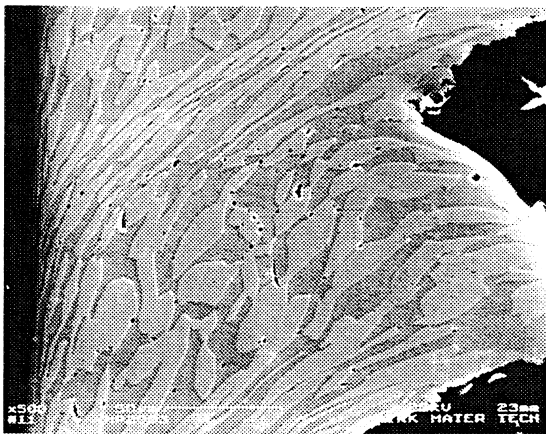
Fig. 16—Cyclic deformation of a chip of PM 2205 steel at a cutting speed of 200 m/min.

It is normally accepted that deformation is concentrated to adiabatic shear bands if serrated chips are formed. As an example, the microstructure of a chip of PM 2205 steel at cutting speed of 200 m/min is shown in Figure 16. Heavy and slight deformation occur alternatively inside the chip. The heavy deformation zone seems like an adiabatic shear band. According to a previous study,^[2] formation of heavily concentrated deformation zones in the chips of stainless steels was supposed to be due to high work hardening and low thermal conductivity. In addition, changes of the direction of strain in the different deformation zones (heavy and slight deformation) in the primary shear zone can also be recognized, which indicates that there have been cyclic changes of the shear angle of the stainless steel chips. The changes of shear angle may also be partially responsible for the serrations of the stainless steel chips, which agrees with an earlier study.^[6]
