**THE AXIAL LOAD-DISPLACEMENT BEHAVIOR OF
STEEL STRANDS USED IN ROCK REINFORCEMENT**

Doctoral Dissertation

Ilkka Satola

**Helsinki University of Technology
Department of Civil and Environmental Engineering
Rock Engineering**

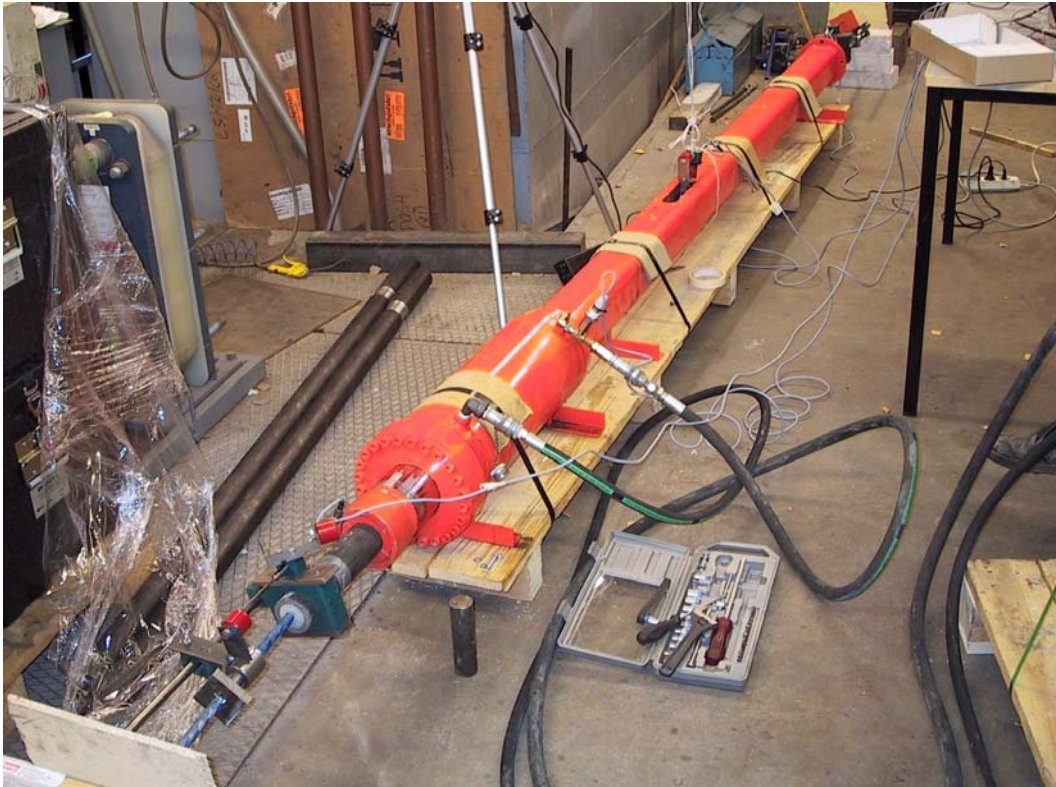
Figure 3. Double pipe axial testing machine (Satola & Hakala 2001a).

The final test system consisted of a pulling device, an electric hydraulic pump, an RHS testing pipe, a wedge system for the connection of test steel pipes, measuring instruments, and a portable PC for data collection (Figure 3).

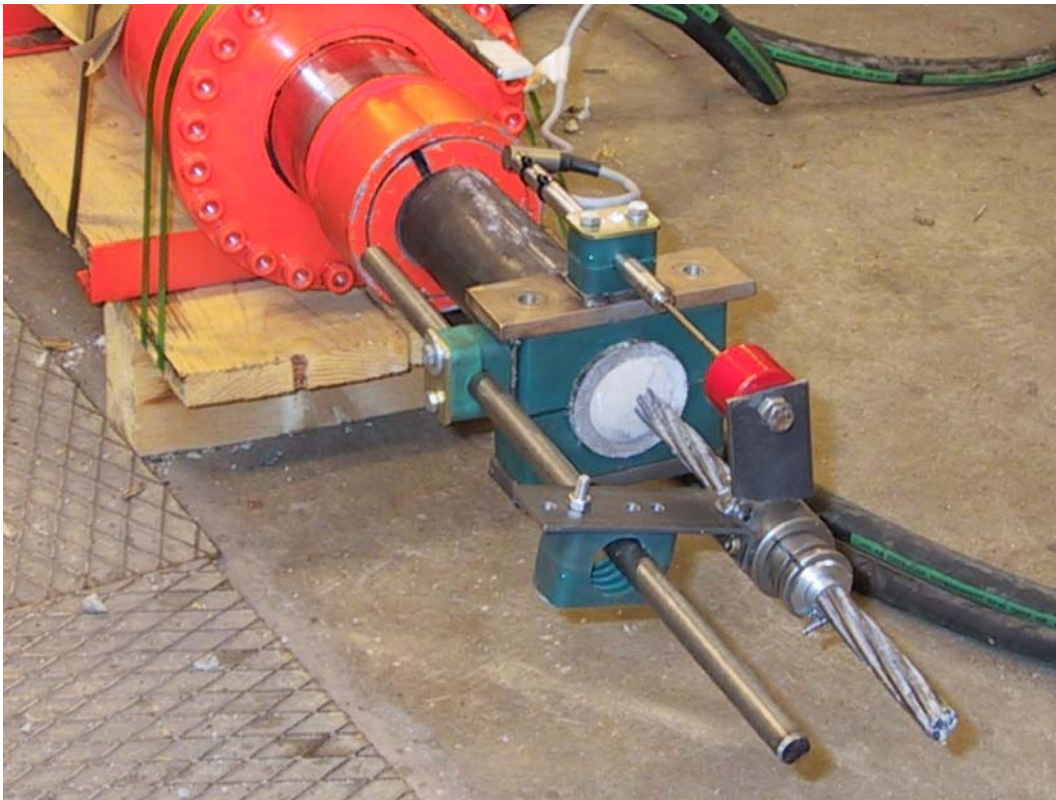
Figure 4. The connection of the displacement transducer to the test strand (Satola & Hakala 2001a).

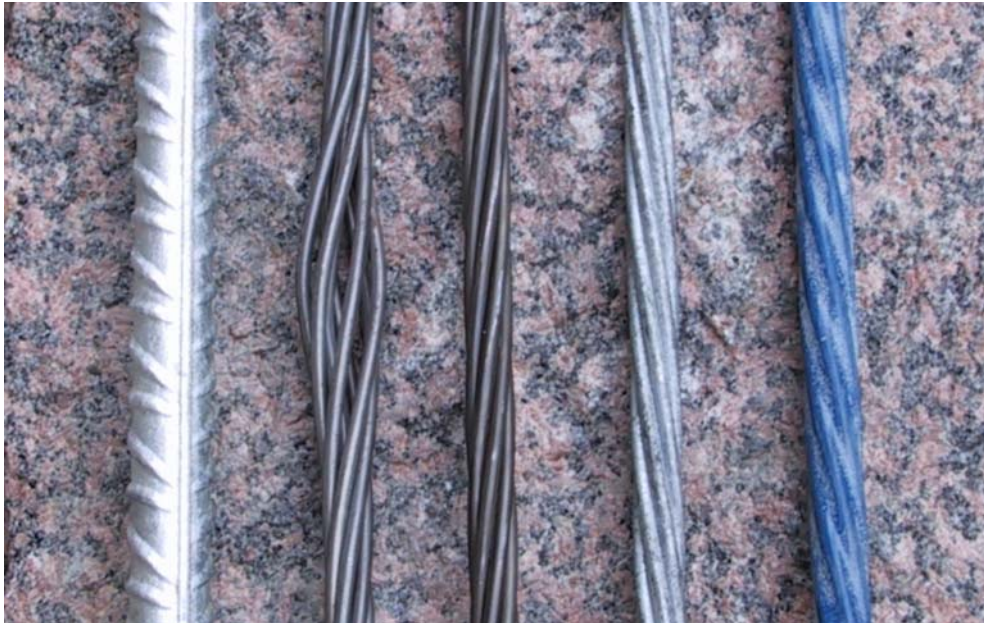
Figure 7. Test bolt types. From left: Rebar (with hot-dip galvanizing in the figure), bulbed strand, standard steel strand, hot-dip galvanized steel strand and epoxy-coated steel strand (Satola & Hakala 2001b).

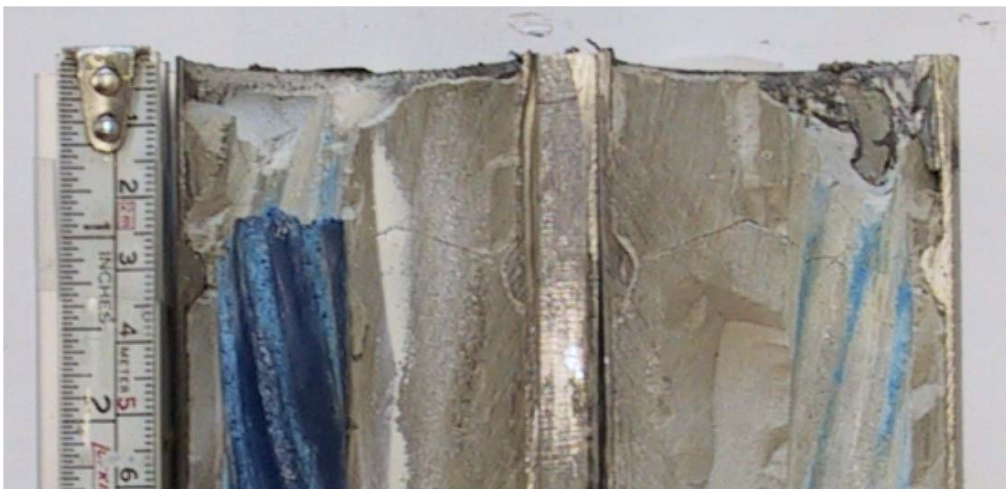
Figure 9. The split test pipe and the grout column after the test. Welded ring inside surface of the pipe (30 mm from the end of the pipe in the figure).

It was suspected that the bond between the smooth inside surface of the steel pipe and the grout was not strong enough to transfer the load from the steel pipe to the grout and then further to the test bolt. There was a concern that the steel pipe would slip away from the grout column resulting in unsuccessful test behavior. To prevent the grout column from slipping, a ring was welded to the inside surface of each steel pipe to create a ridge at the same end of the pipe where the round rods were welded (Figure 9).

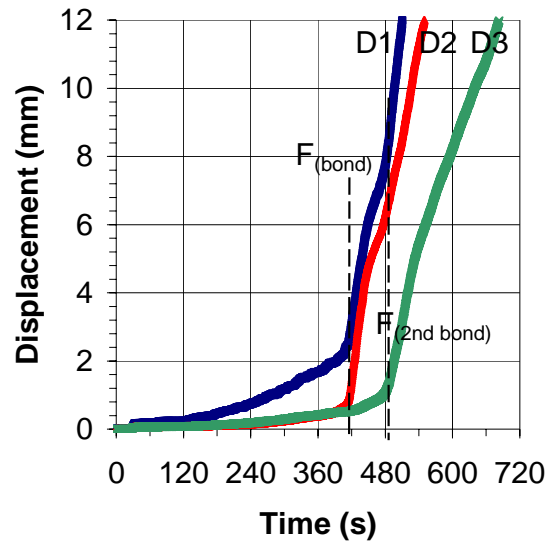
Figure 10. Evaluation of the bond strength.

$F_{(2nd\ bond)}$: Pull-out load which occurs in the other embedment section after the first bond failure has already occurred (Figure 10).

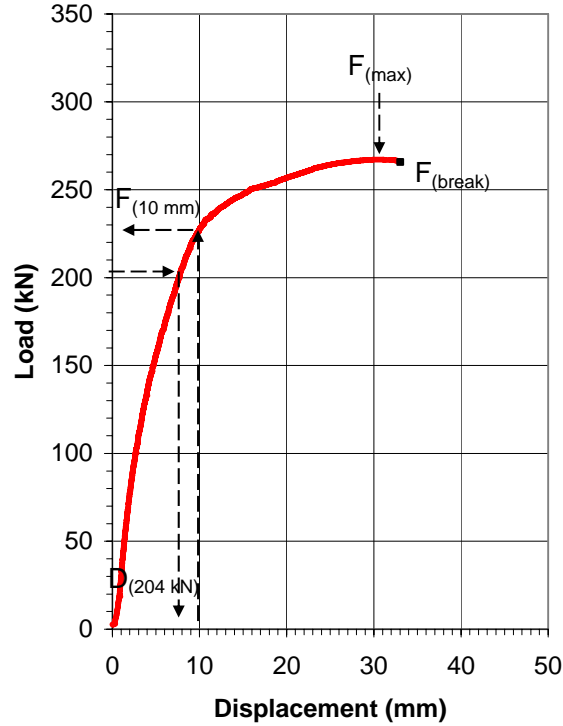
Figure 11. Evaluation of the parameters. Displacement is the value measured between steel pipes (D1).

$F_{(break)}$: Pull-out load when the bolt failure occurs (Figure 11).

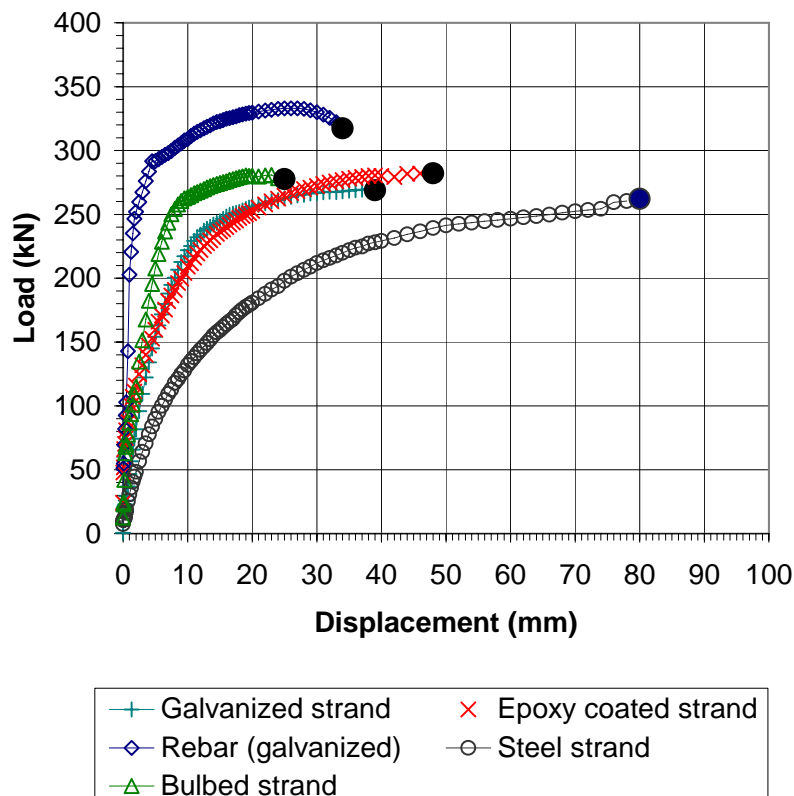
Figure 12. Axial double pipe test results. The average load-displacement curves of each test bolt type with an embedment length of 2000 mm. Displacement is the value measured between steel pipes (D_1). Symbol ● denotes that test bolt ruptured (after Satola & Aromaa 2004).

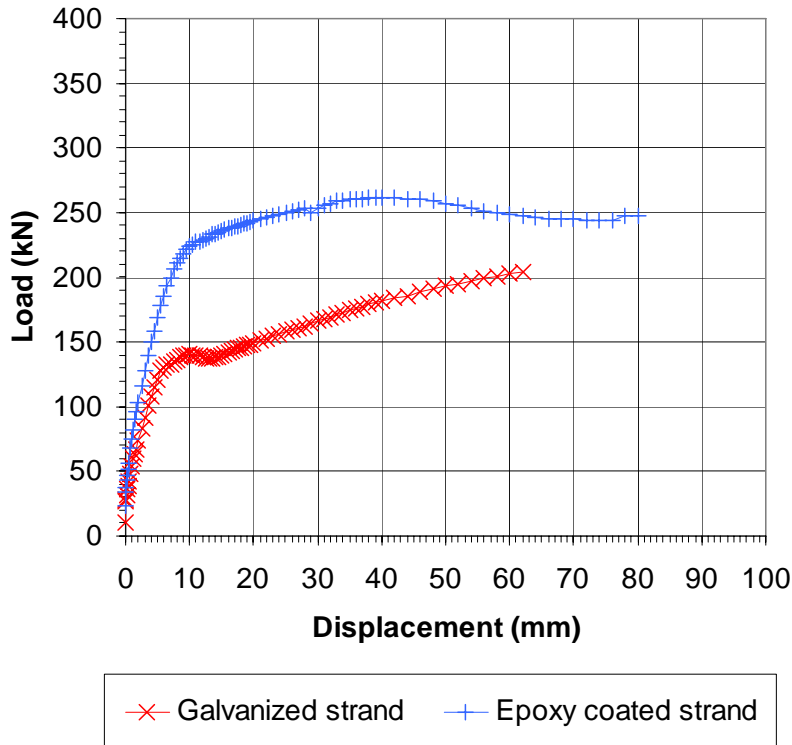
Figure 15. Axial double pipe test results. The average load-displacement curves of two test bolt type with an embedment length of 750 mm (Satola & Aromaa 2004).

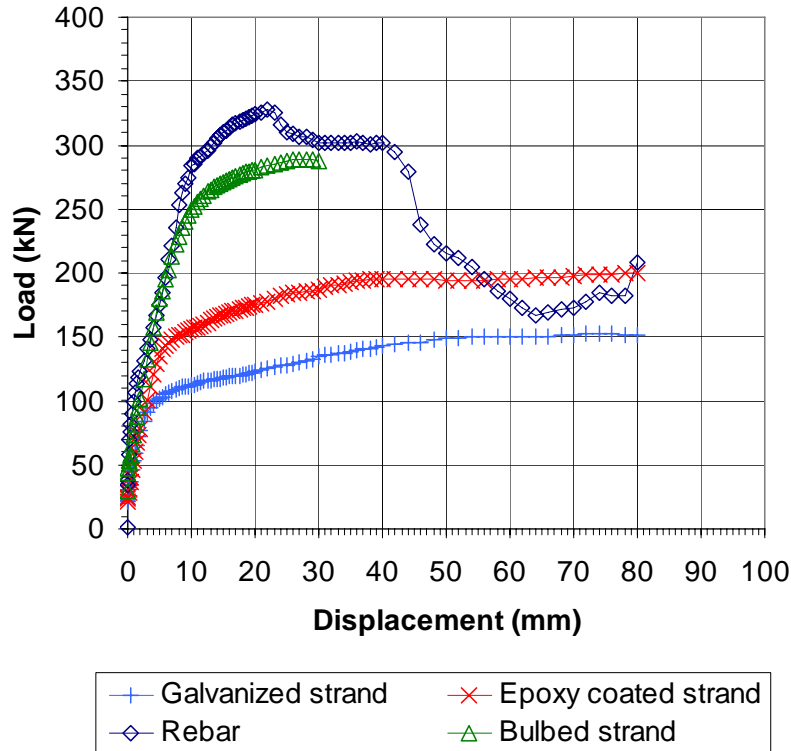
Figure 16. Axial double pipe test results. The average load-displacement curves of each test bolt type with an embedment length of 500 mm (Satola & Aromaa 2004).

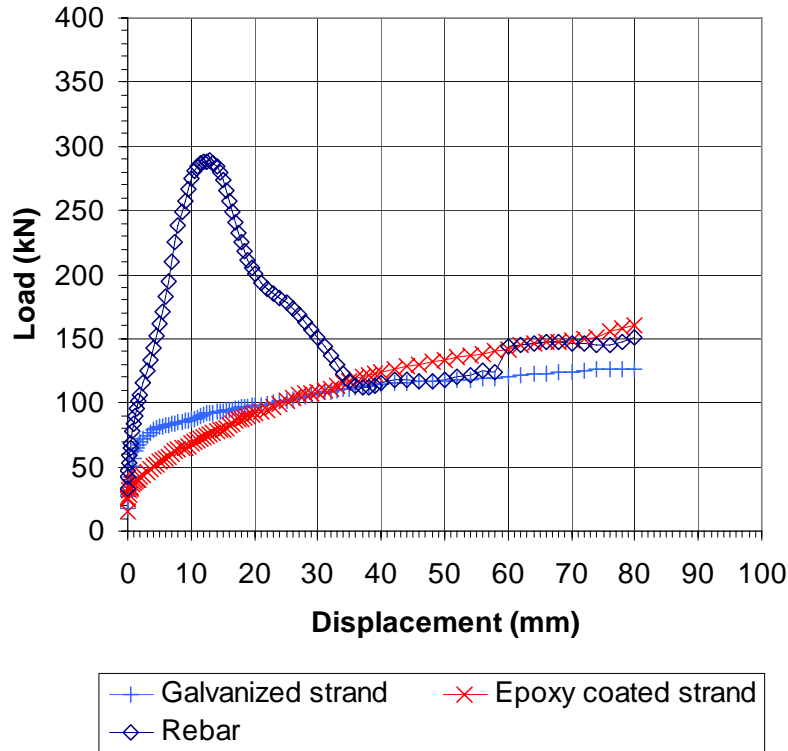
Figure 17. Axial double pipe test results. The average load-displacement curves of each test bolt type with an embedment length of 250 mm (Satola & Aromaa 2004).

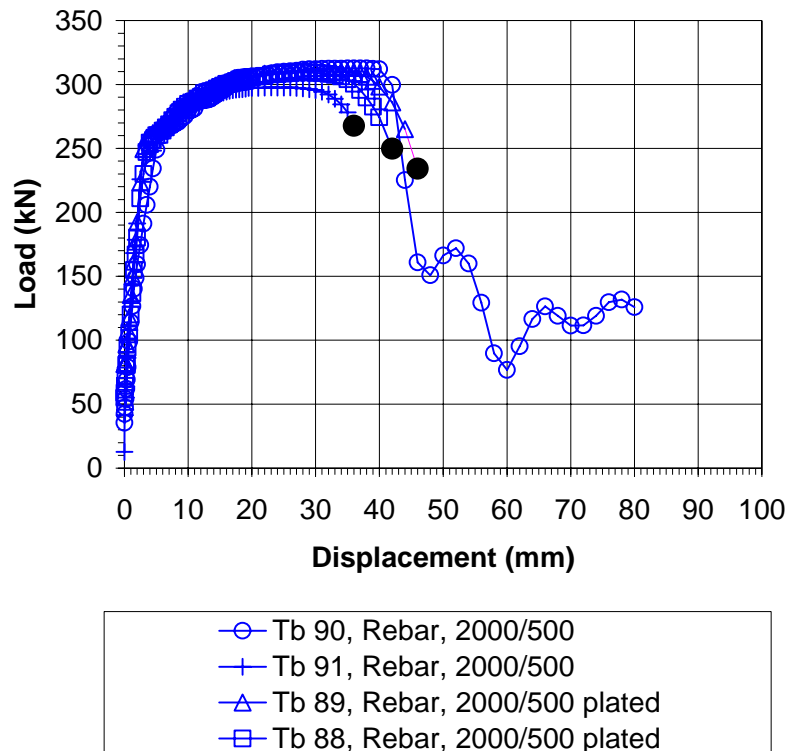
Figure 18. Axial double pipe test results of galvanized rebars of unequal embedment lengths (2000 mm/500 mm) and plates. Symbol • denotes that test bolt ruptured.

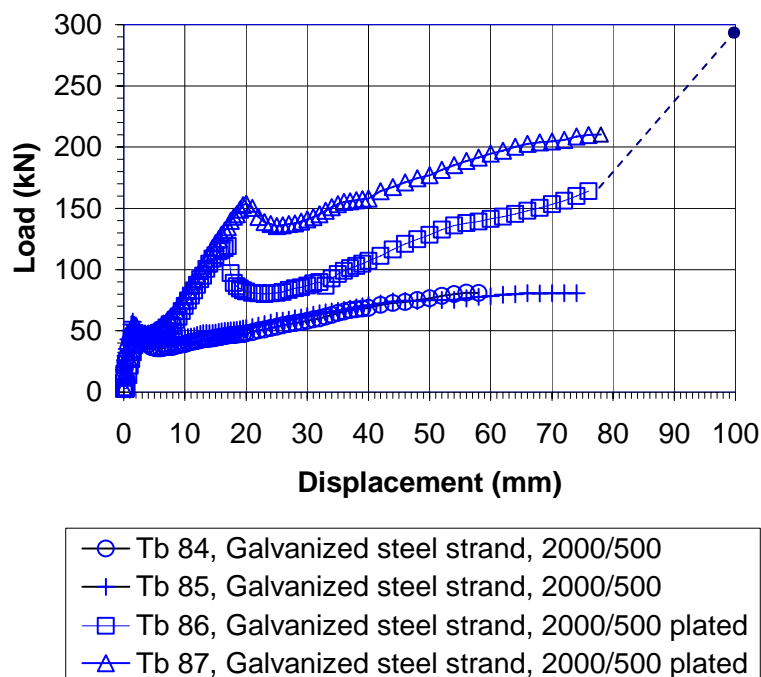
Figure 20. Axial double pipe test results of galvanized steel strands of unequal embedment lengths (2000 mm/500 mm) and plates. Recording the test data at the end of the test no. 86 failed because of problems with displacement transducers (spotted line). Symbol • denotes that test bolt ruptured.

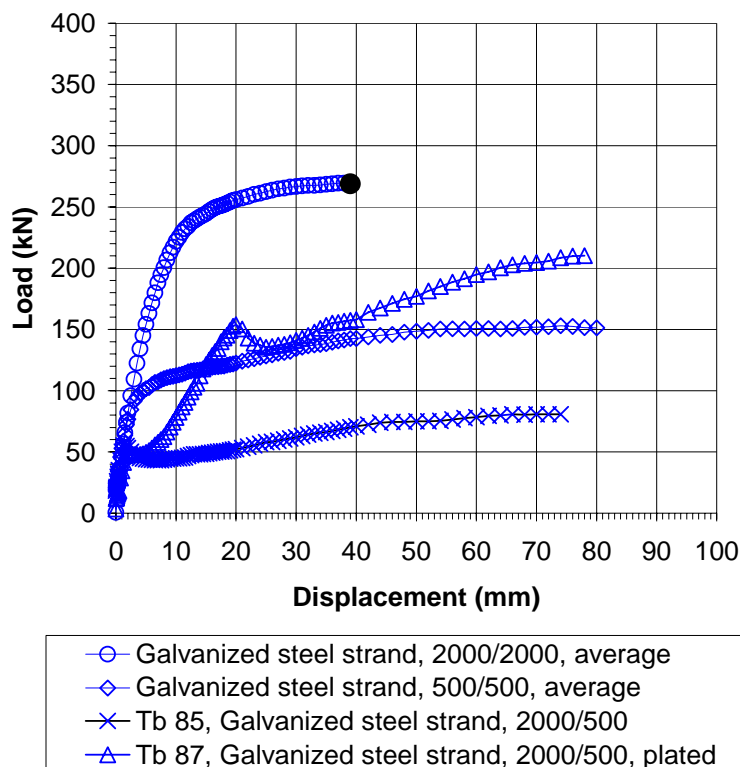
Figure 21. The difference in the axial behavior of galvanized steel strand with different embedment length variations and plated strands. Symbol ● denotes that test bolt ruptured.

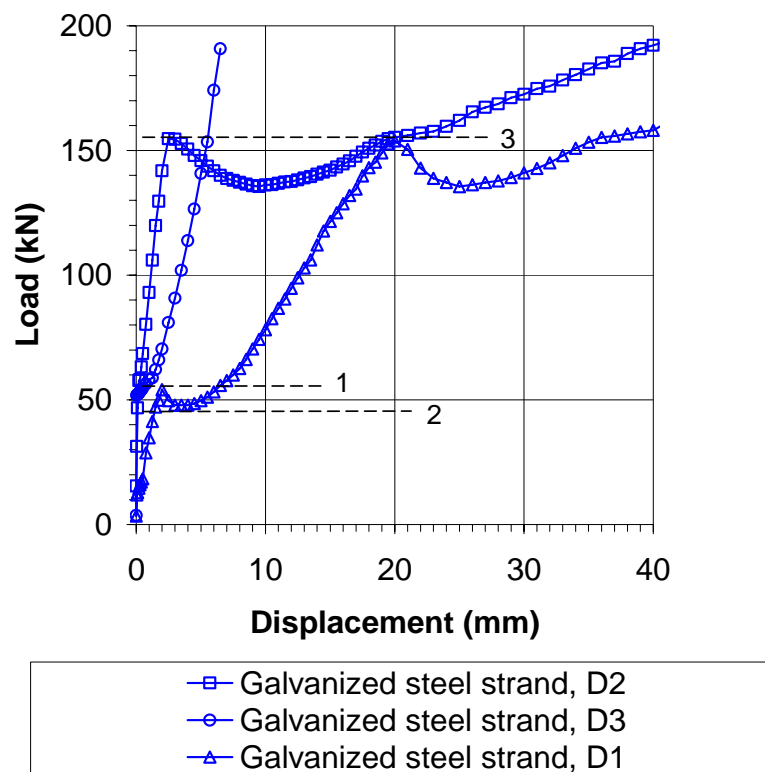
Figure 22. Example of different stages of axial behavior of galvanized steel strand with unequal embedment lengths (2000 mm/500 mm, plated). Test bolt no. 87.

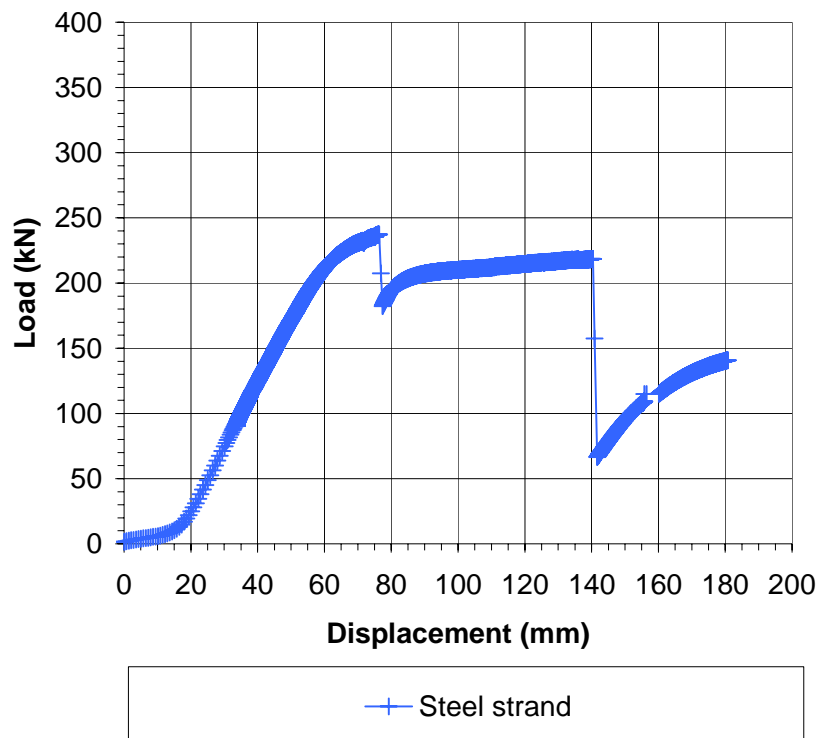
Figure 23. Load-displacement behavior of ungrouted steel strand with a test length of 4020 mm. The test was performed by a double pipe test machine.

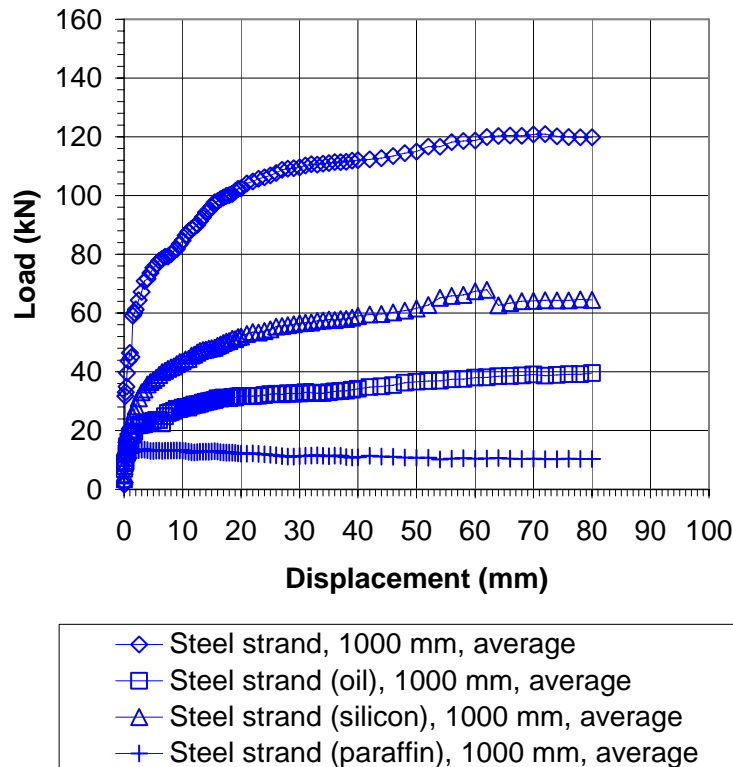
Figure 24. The averaged test results of steel strands with different debonding materials (after Satola 1999a,b).

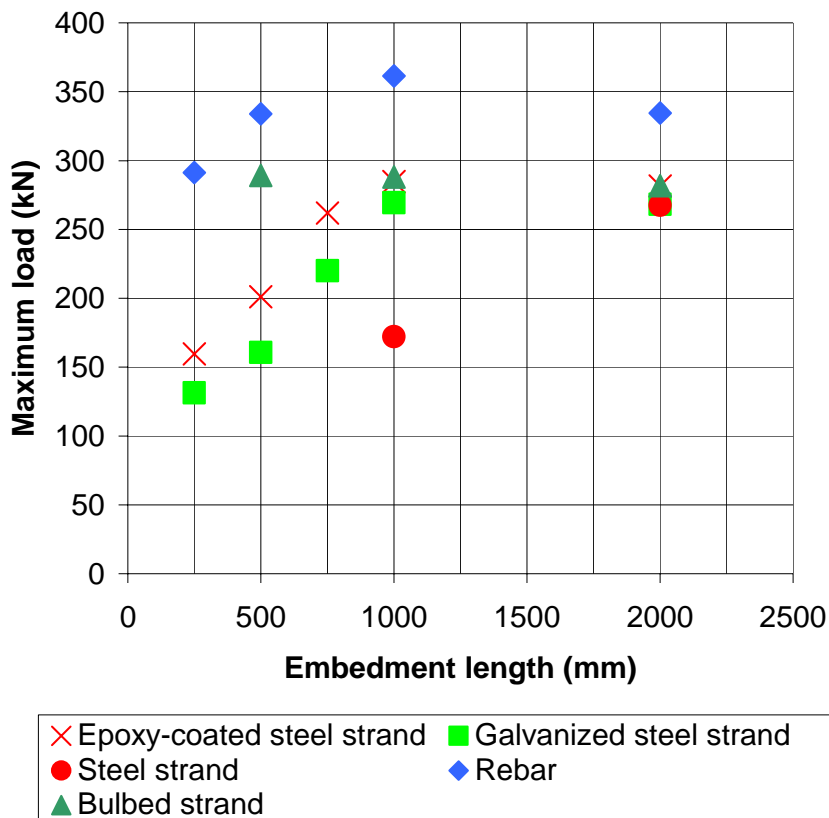
Figure 25. The averaged maximum load at the different embedment lengths.

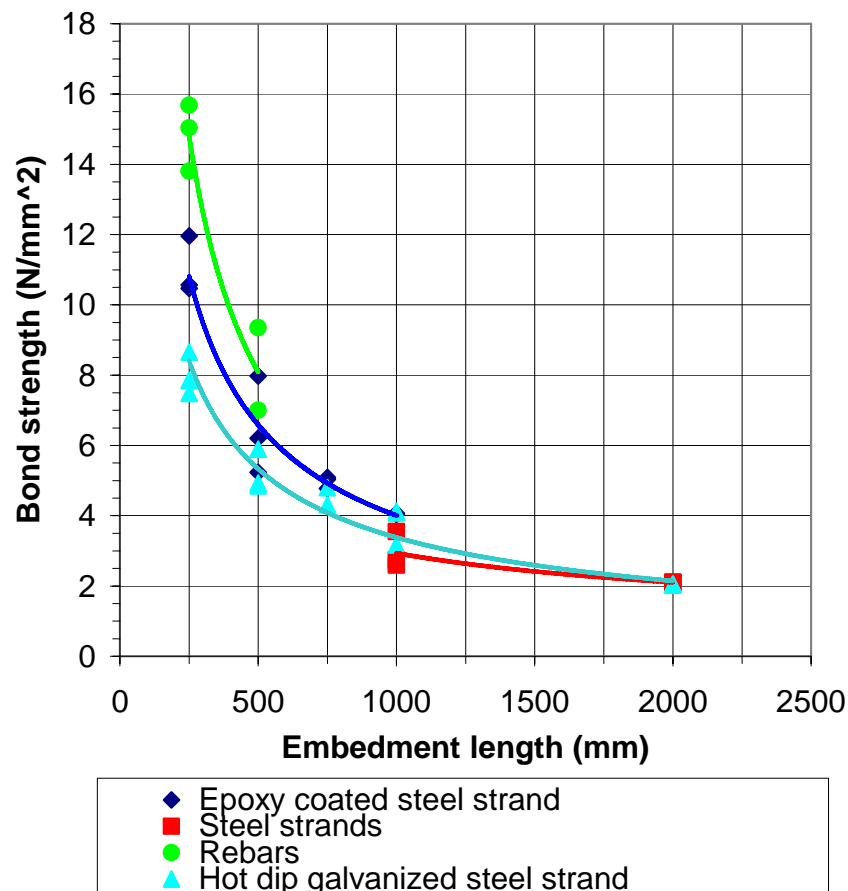
Figure 26. The ultimate bond strengths (UBS) of test bolt types with different embedment lengths. Bond strength is defined as the ultimate load divided by the bond area of the bolt.

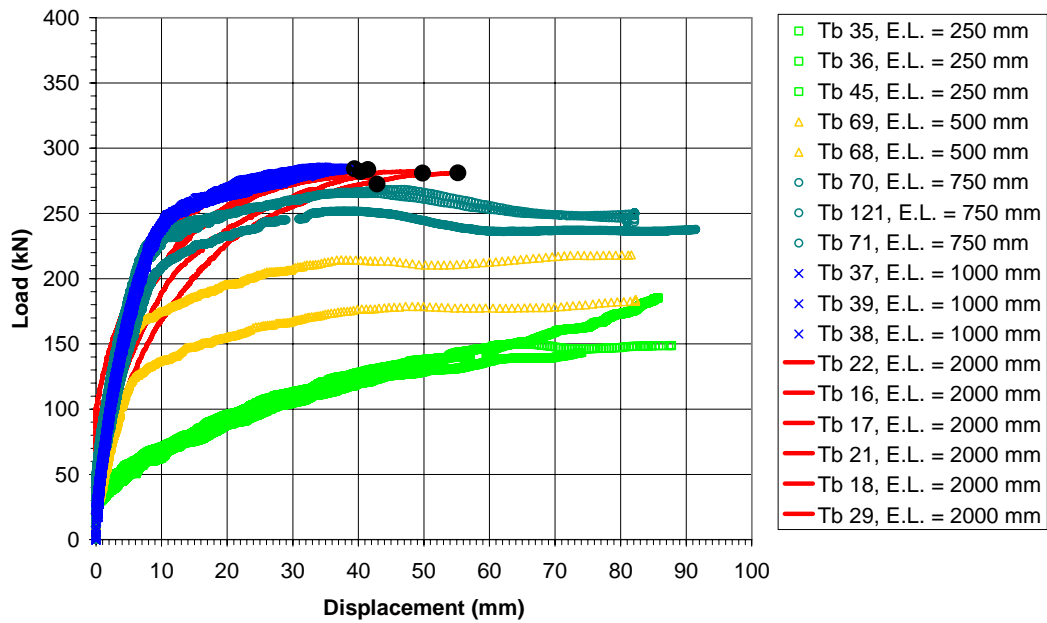
Figure A.2. The axial double pipe test results of epoxy-coated steel strand with embedment lengths of 250 mm, 500 mm, 750 mm, 1000 mm and 2000 mm. Symbol ● denotes that test bolt ruptured.

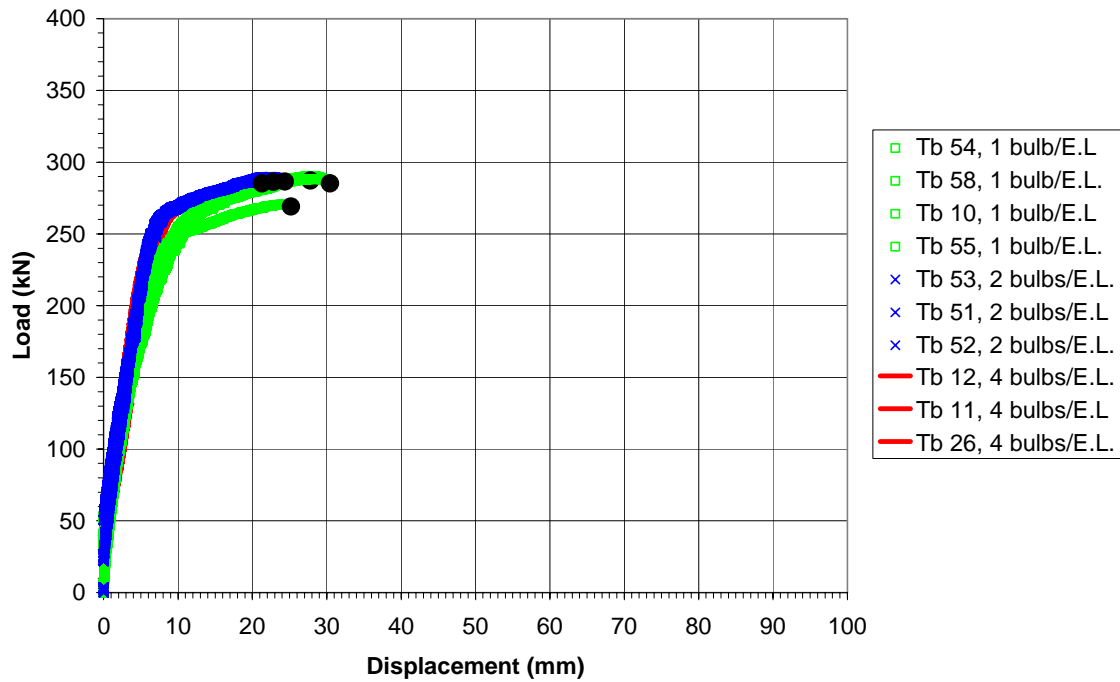
Figure A.4. The axial double pipe test results of bulbed strand with embedment lengths of 250 mm, 1000 mm and 2000 mm. Symbol ● denotes that test bolt ruptured. All the test bolts broke off.

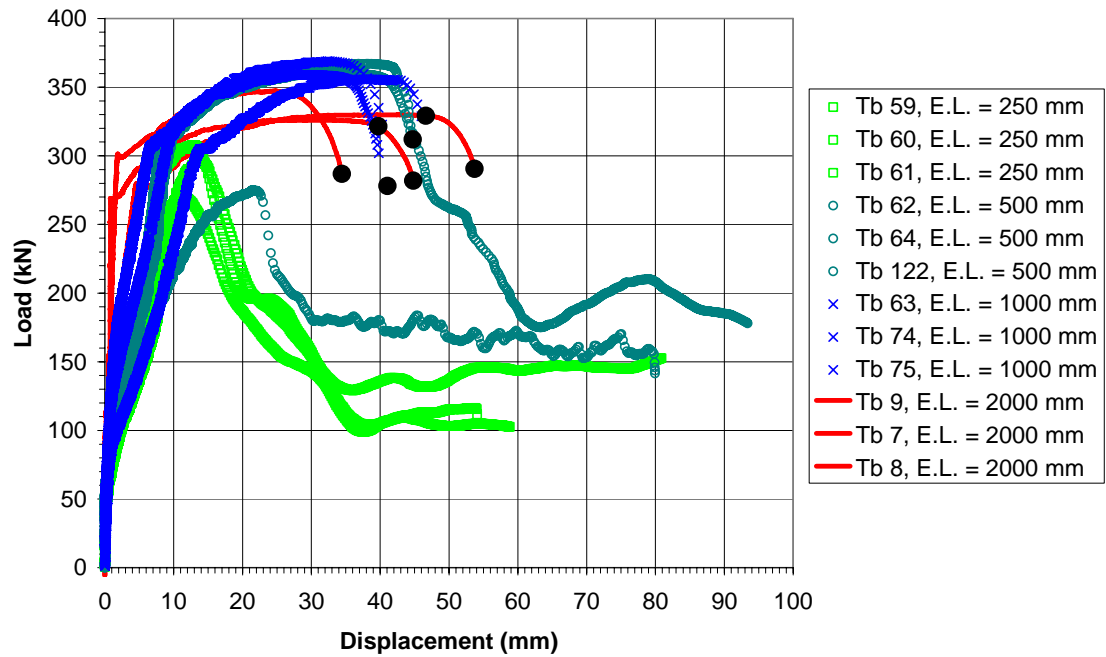
Figure A.5. The axial double pipe test results of rebar with embedment lengths of 250 mm, 500 mm and 1000 mm and galvanized rebar of 2000 mm. Symbol ● denotes that test bolt ruptured.

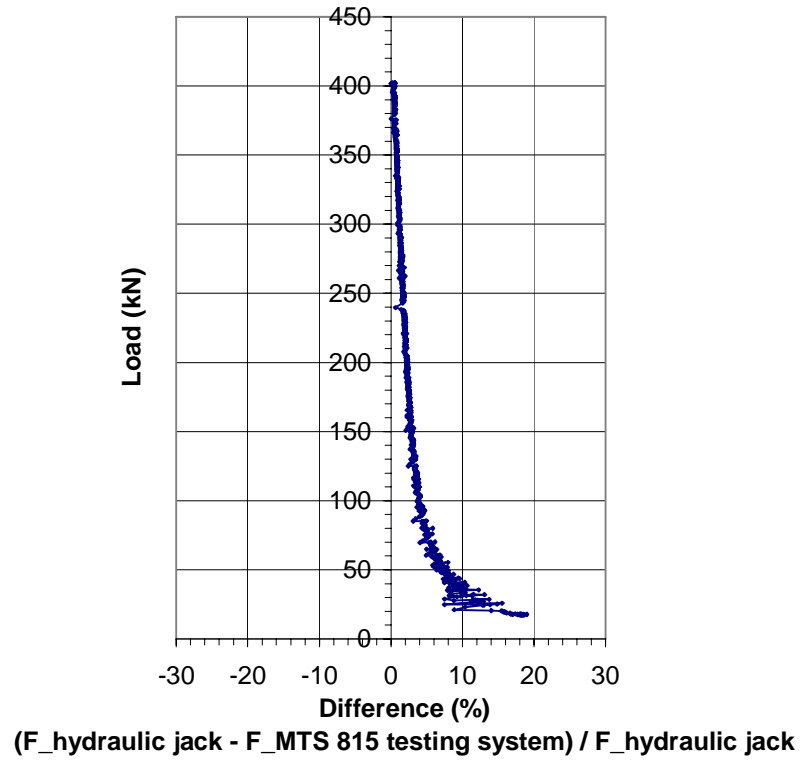
Figure B.1. The calibration curve of the hydraulic jack (double pipe) by the MTS 815 testing system.

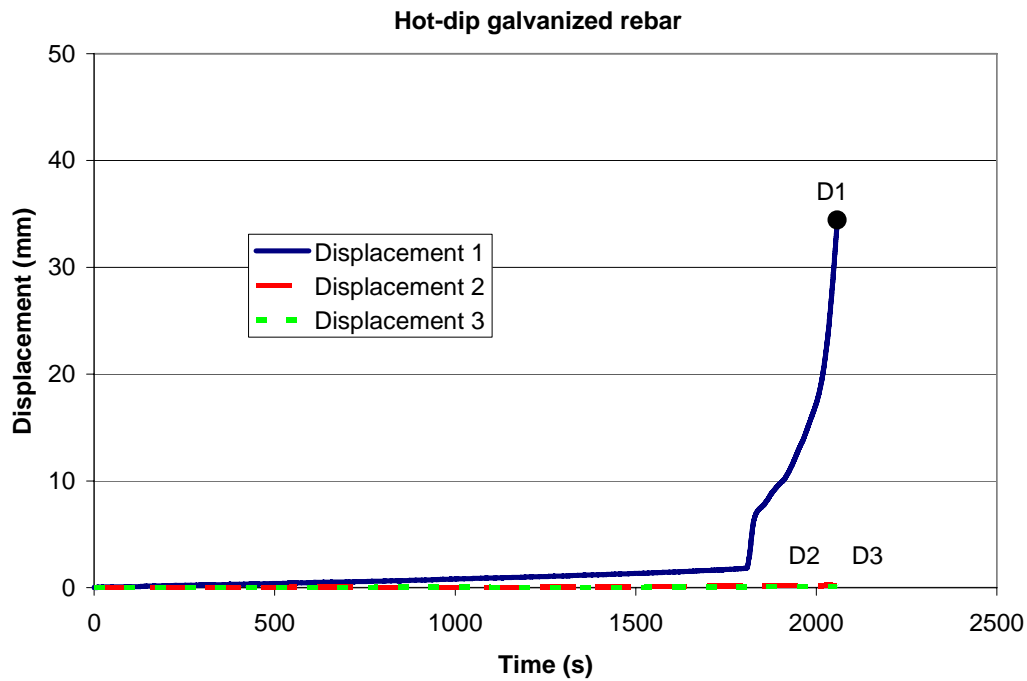
Figure C. 1. Time-displacement diagram of hot-dip galvanized rebar with embedment length of 2000 mm (test bolt no. 7). Symbol ● denotes that bolt ruptured.

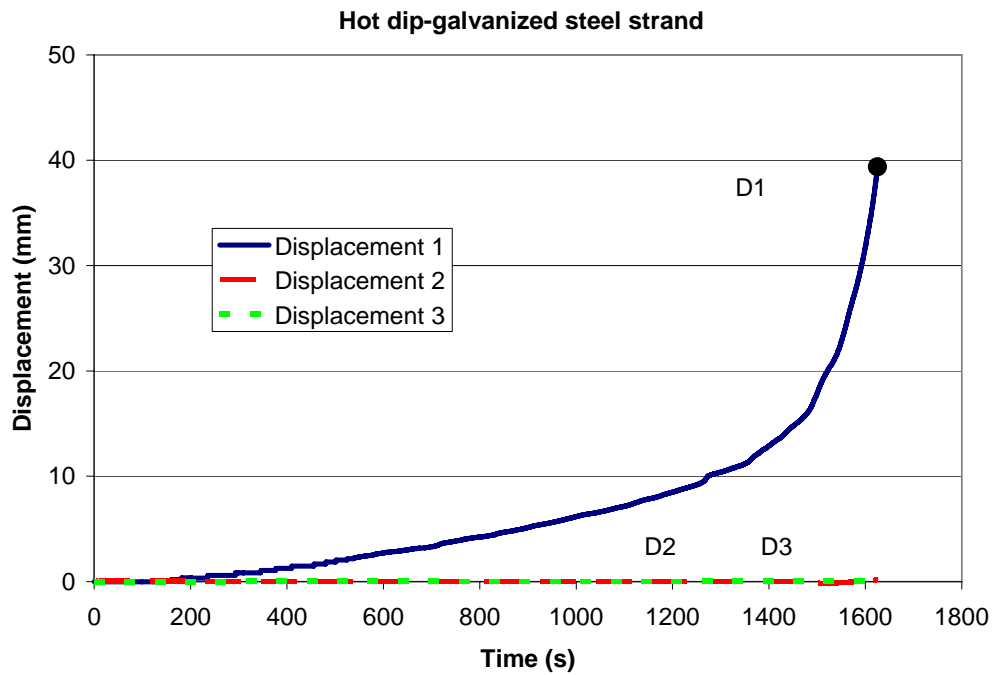
Figure C. 2. Time-displacement diagram of hot-dip galvanized steel strands with embedment length of 2000 mm (test bolt no. 24). Symbol ● denotes that bolt ruptured.

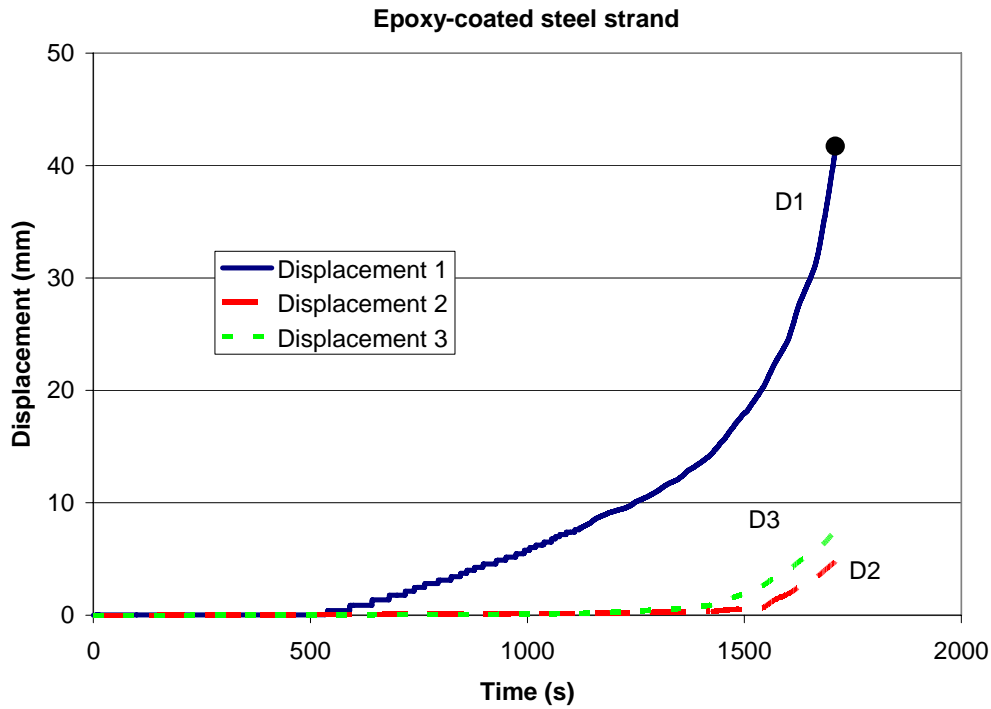
Figure C. 3. Time-displacement diagram of epoxy-coated steel strand with embedment length of 2000 mm (test bolt no. 22). Symbol ● denotes that bolt ruptured.

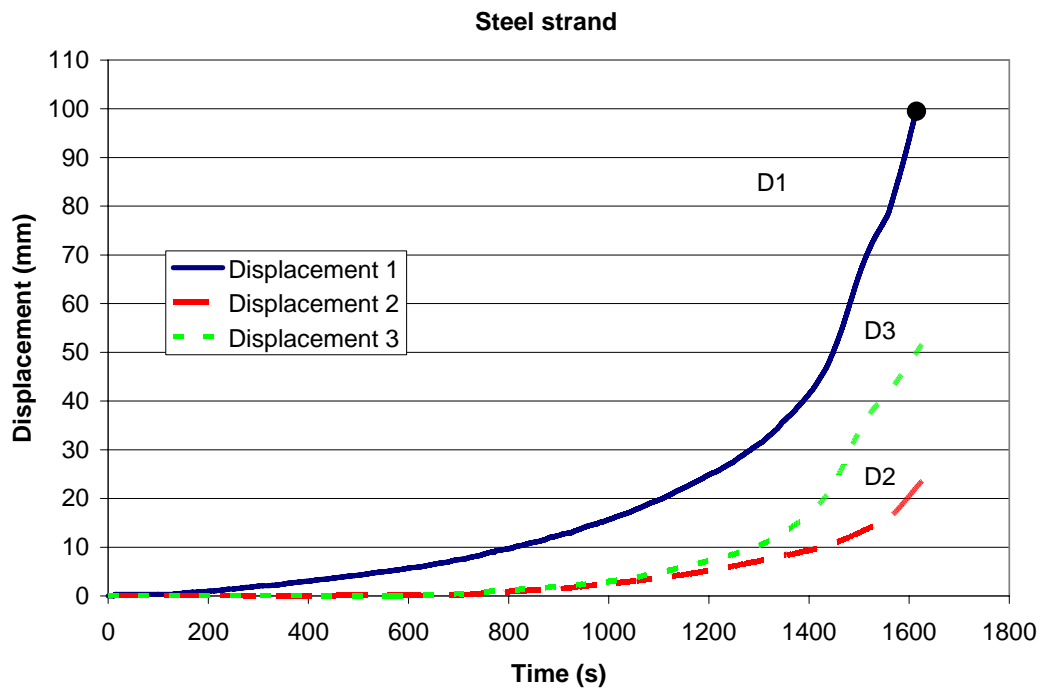
Figure C. 4. Time-displacement diagram of standard steel strand with embedment length of 2000 mm (test bolt no. 28). Symbol ● denotes that bolt ruptured.

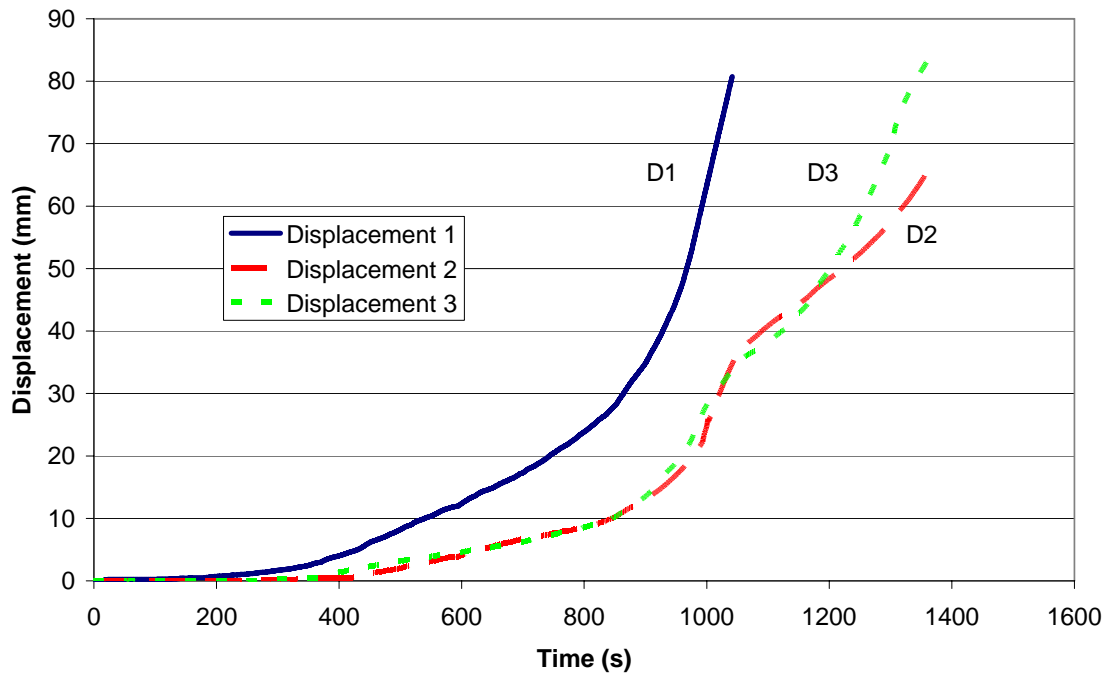
Figure C. 10. Time-displacement diagram of standard steel strand with embedment length of 1000 mm (test bolt no. 123).

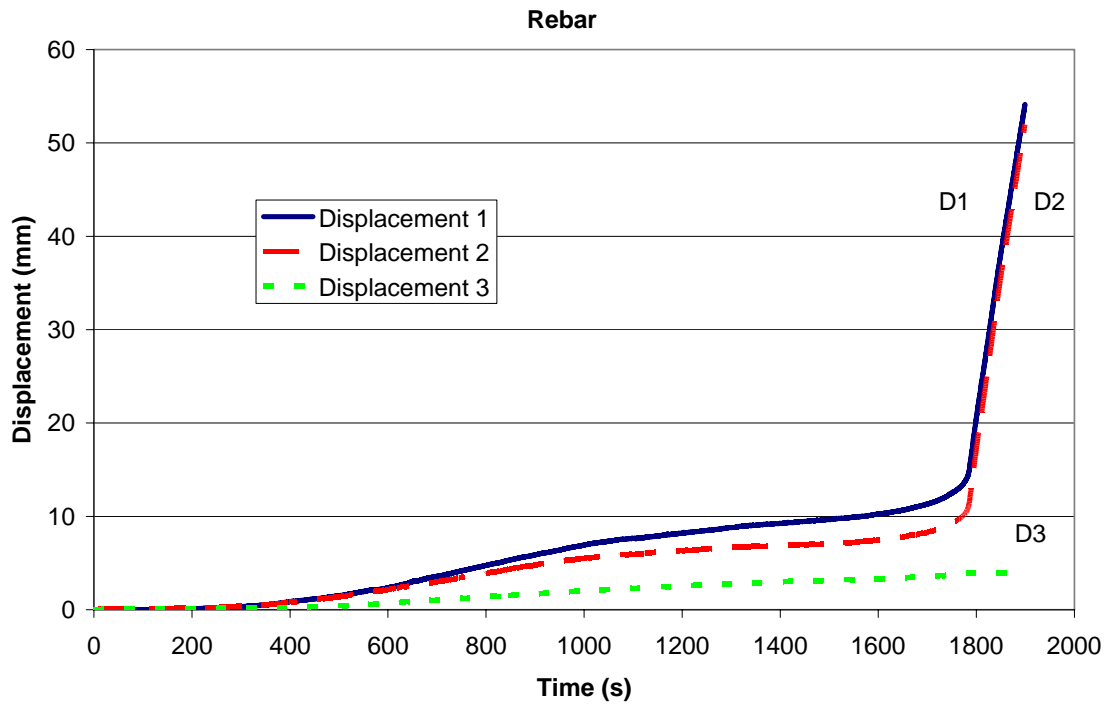
Figure C. 19. Time-displacement diagram of rebar with embedment length of 250 mm (test bolt no. 59).

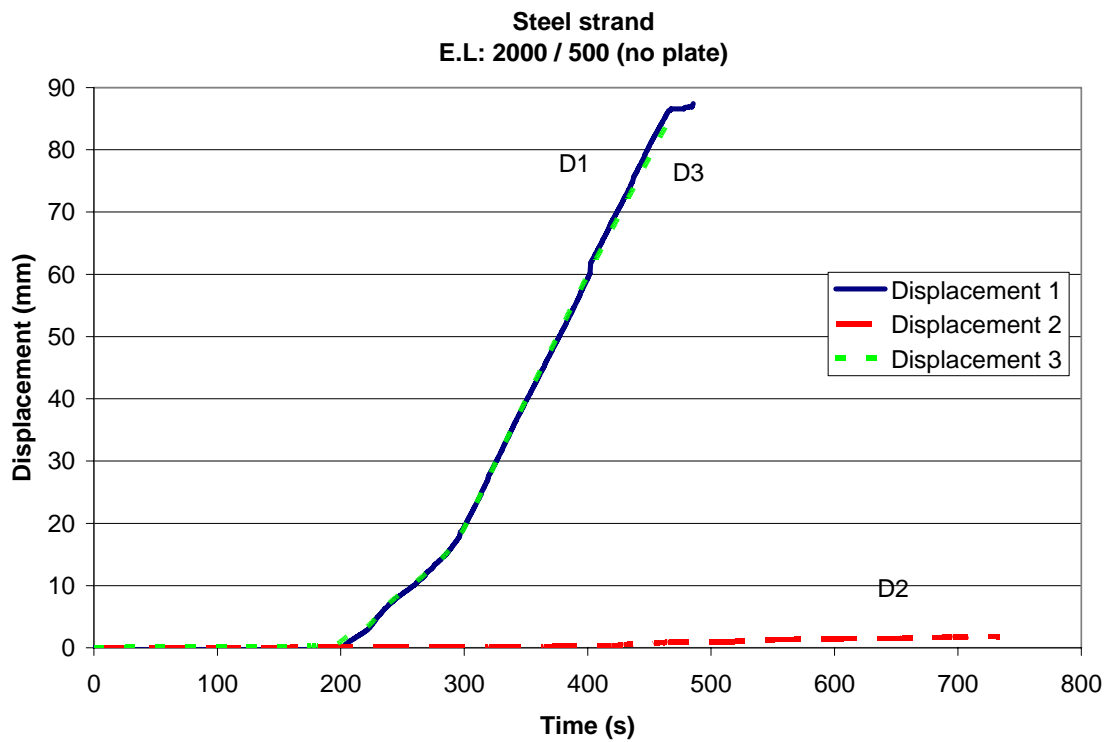
Figure C. 24. Time-displacement diagram of standard steel strand with embedment lengths of 2000 mm and 500 mm (test bolt no. 95).

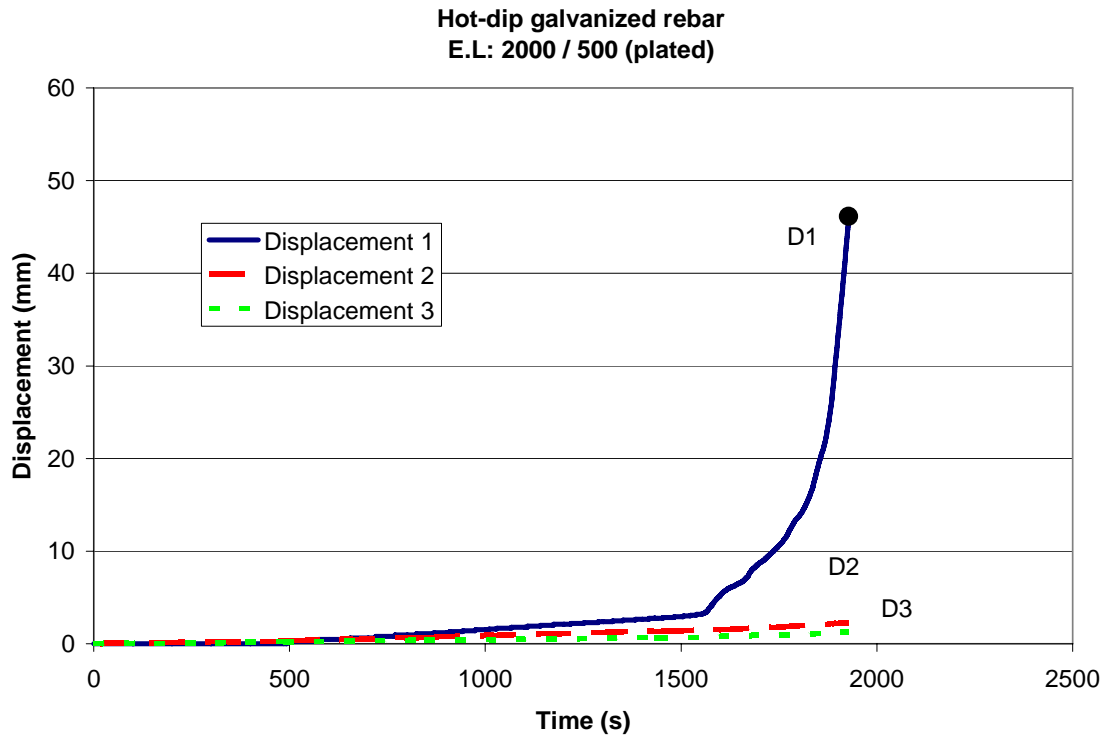
Figure C. 25. Time-displacement diagram of hot-dip galvanized rebar with embedment lengths of 2000 mm and 500 mm (plated) (test bolt no. 89). Symbol ● denotes that bolt ruptured.
